Sample Report Address

# Home Inspection Report

**Red Star Home Inspection, llc**

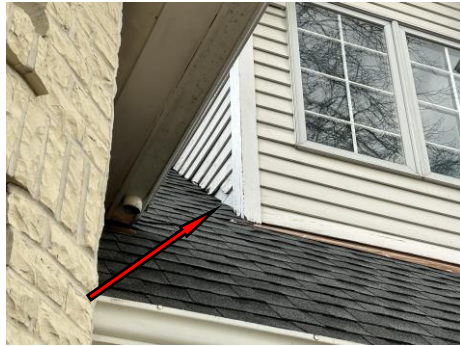
Missing siding front left dormer.

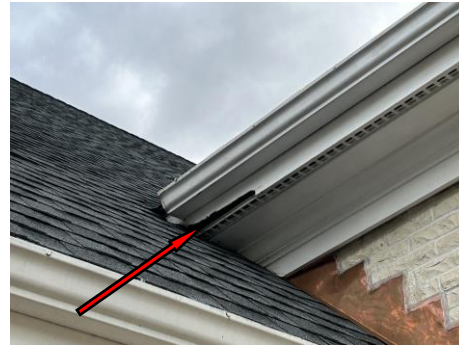
Damaged fascia front center area.

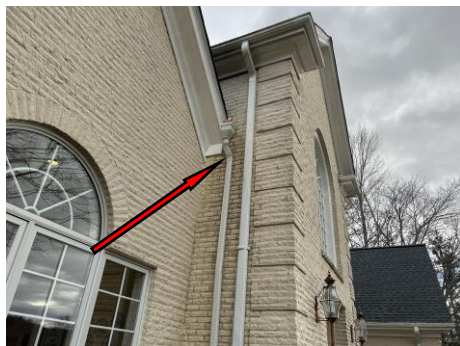
Gutter left of front door appears to leak onto house.

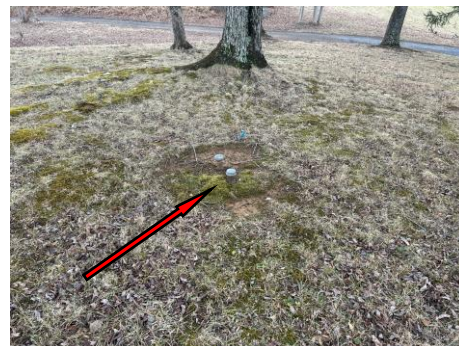
Buried oil tank right side of house.

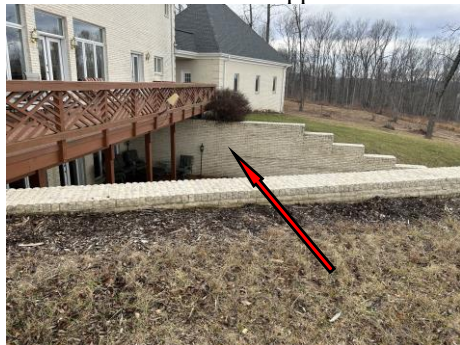
Hand rail on top of retaining wall?

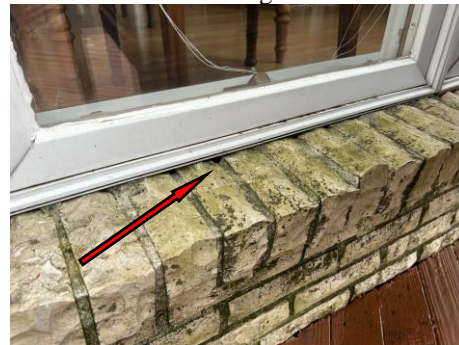
Caulk around windows and doors.

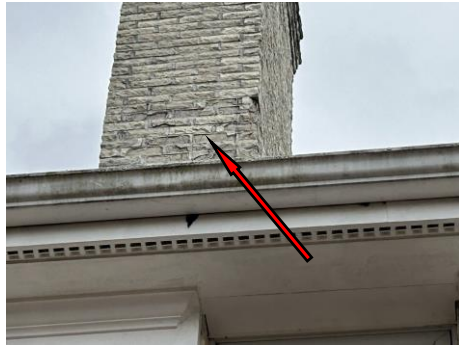
Spalling bricks back side of center chimney.

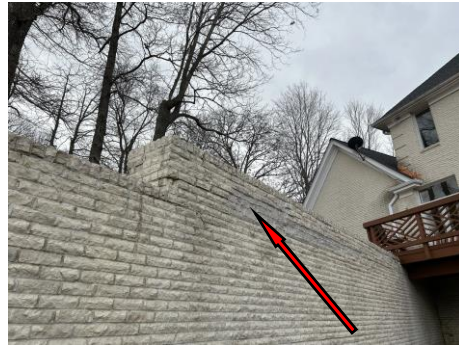
Right side rear retaining wall damaged at the top

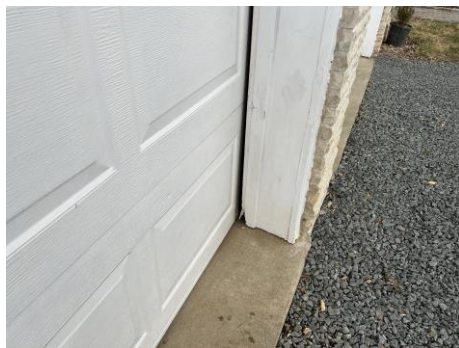
Gap center garage door right side.

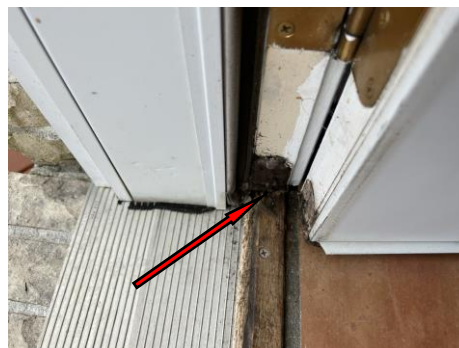
Rotten thresholds doors to deck.

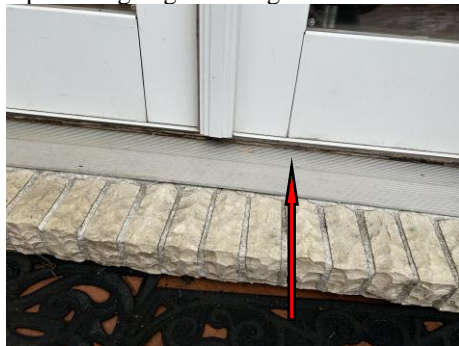
Rotten wood under doors to deck.

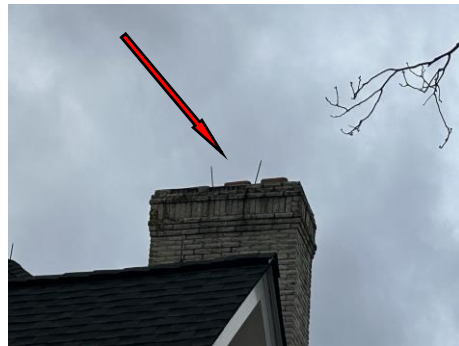
Recommend chimney flue caps.  
Damaged fascia front left corner of garage.

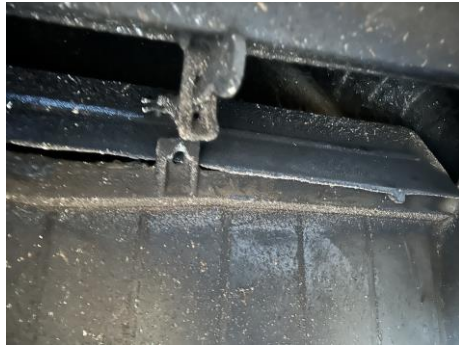
The fireplace damper in the living room is off track, unable to close, the fireplace damper in the master bed room is missing a handle. Recommend replacement and adding of smoke detectors. Budget for windows and doors as these are older single pane/storm windows.

Living room damper off track.

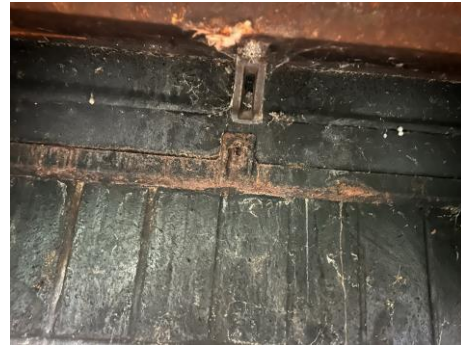
Master bed damper missing handle.

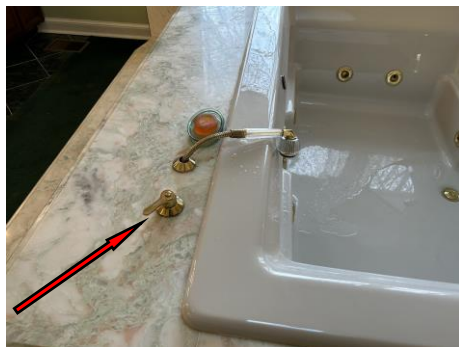
Master bath wand selector knob not working.

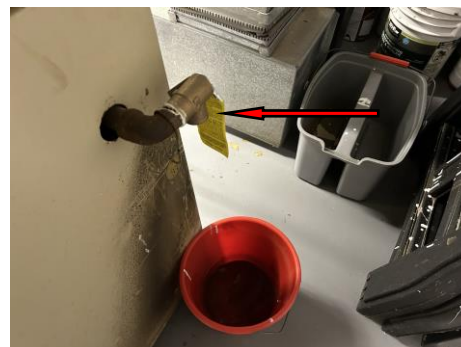
Pressure relief valve on boiler leaking.

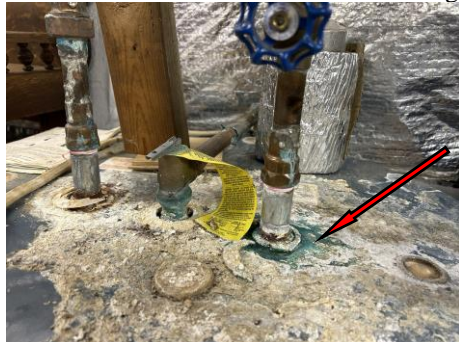
Leak on top of water heater.

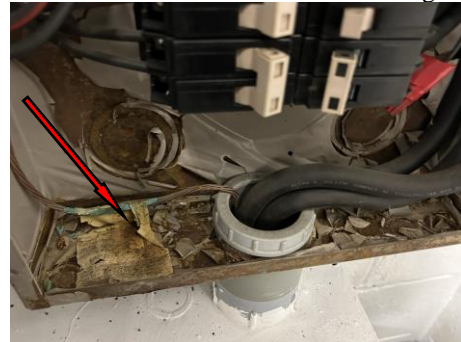
Rust in the bottom of the right panel box.
